REPORT ON EXISTING POOL SHELL AND PLUMBING

November 1, 2022

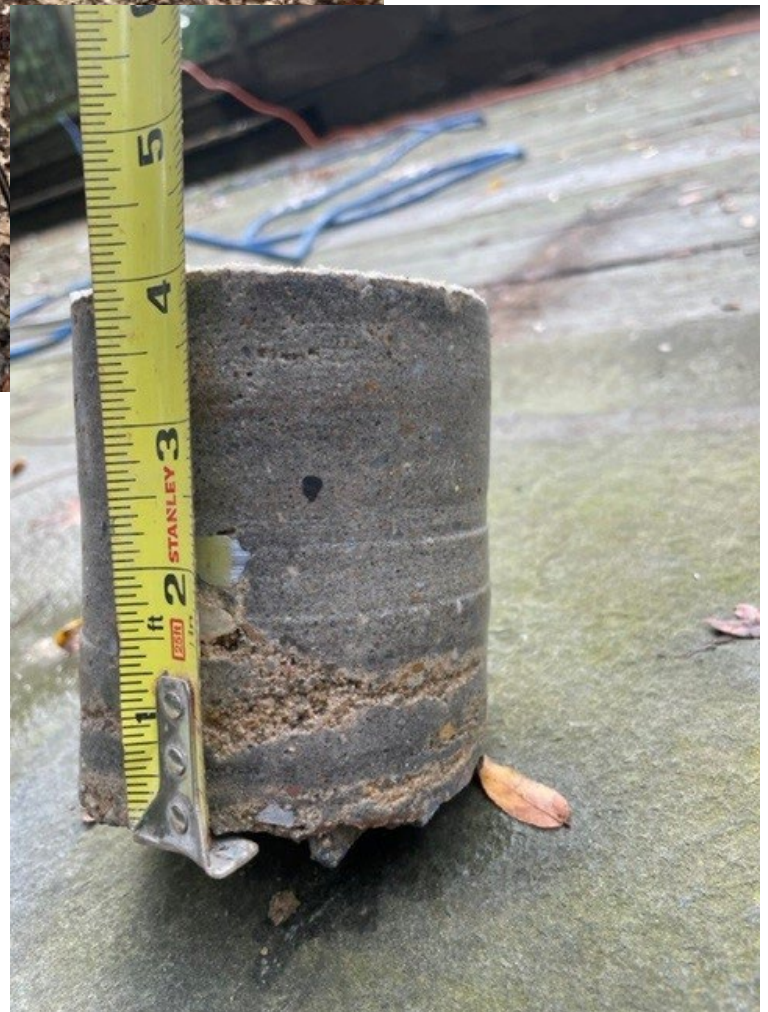
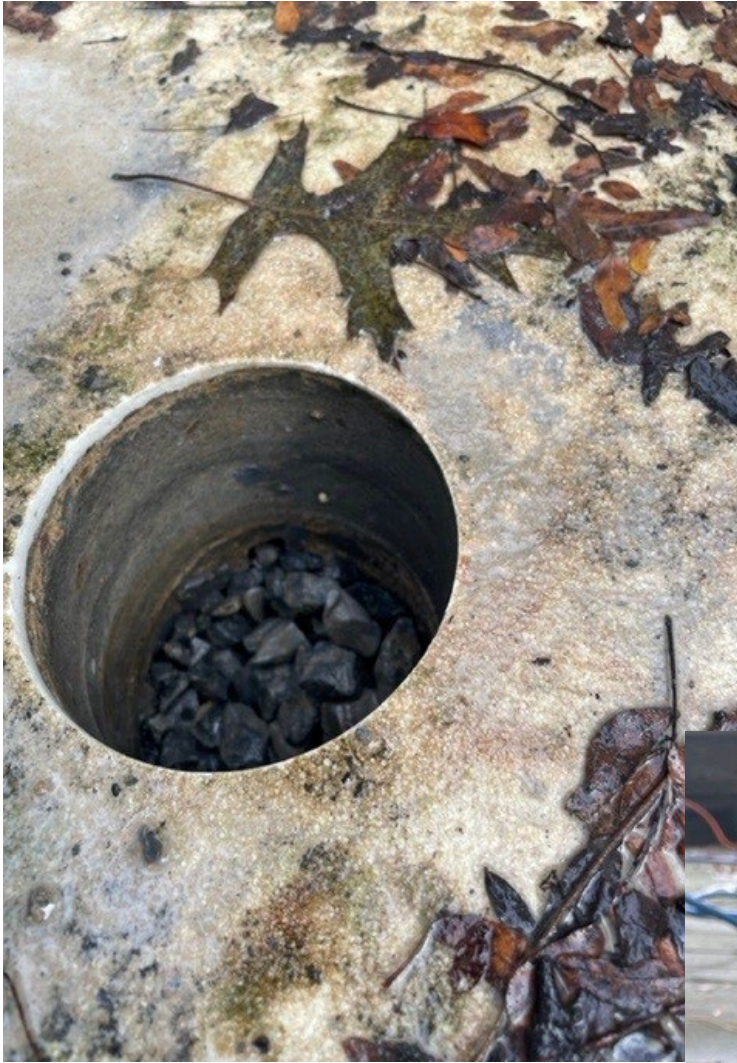
Core Sample # 1: Shallow end of pool left side (Proposed Spa Location)

Thickness of core is 4" overall with approximately 2.5" of clean gunite and 1.5" contaminated layer with sand mix. Only 1/16" of plaster was found on this core.

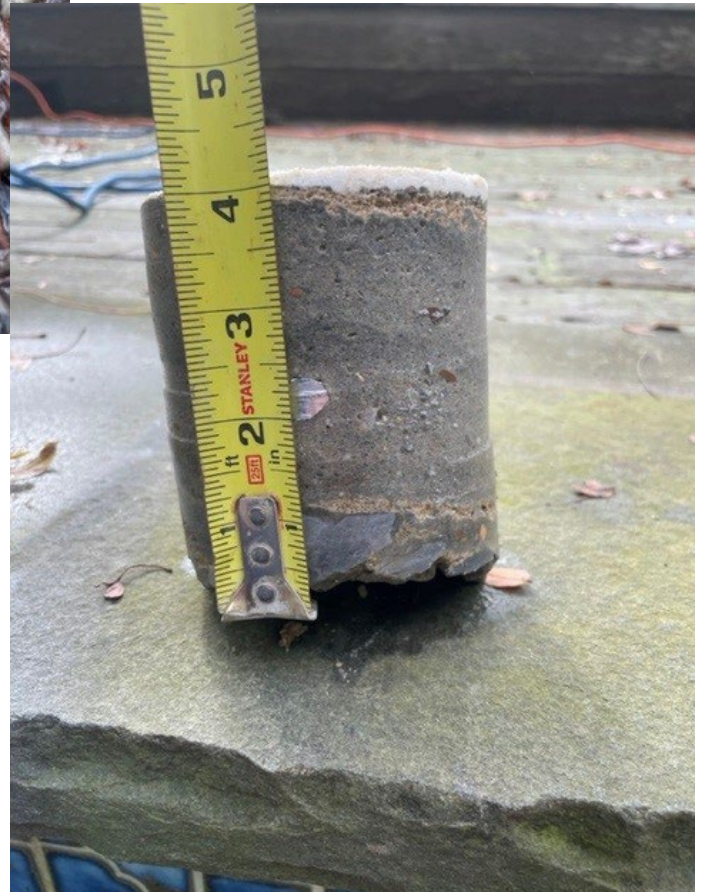
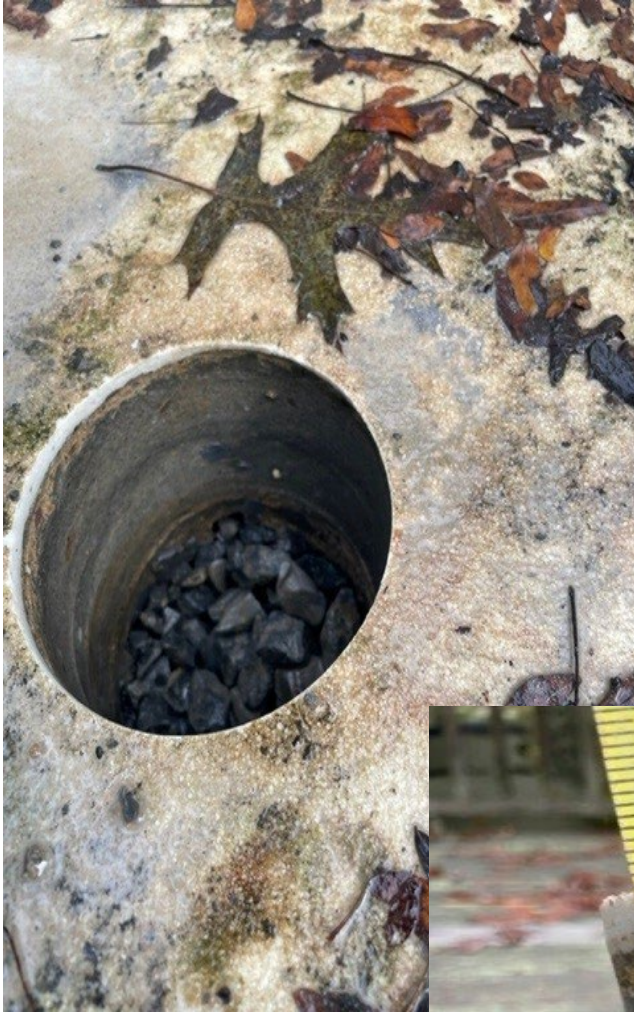
Core sample # 2: Shallow End of Pool

Thickness of core is 4" overall with approximately 3" of clean gunite and 1" contaminated layer with sand mix. Only 1/8" of plaster was found on this core.

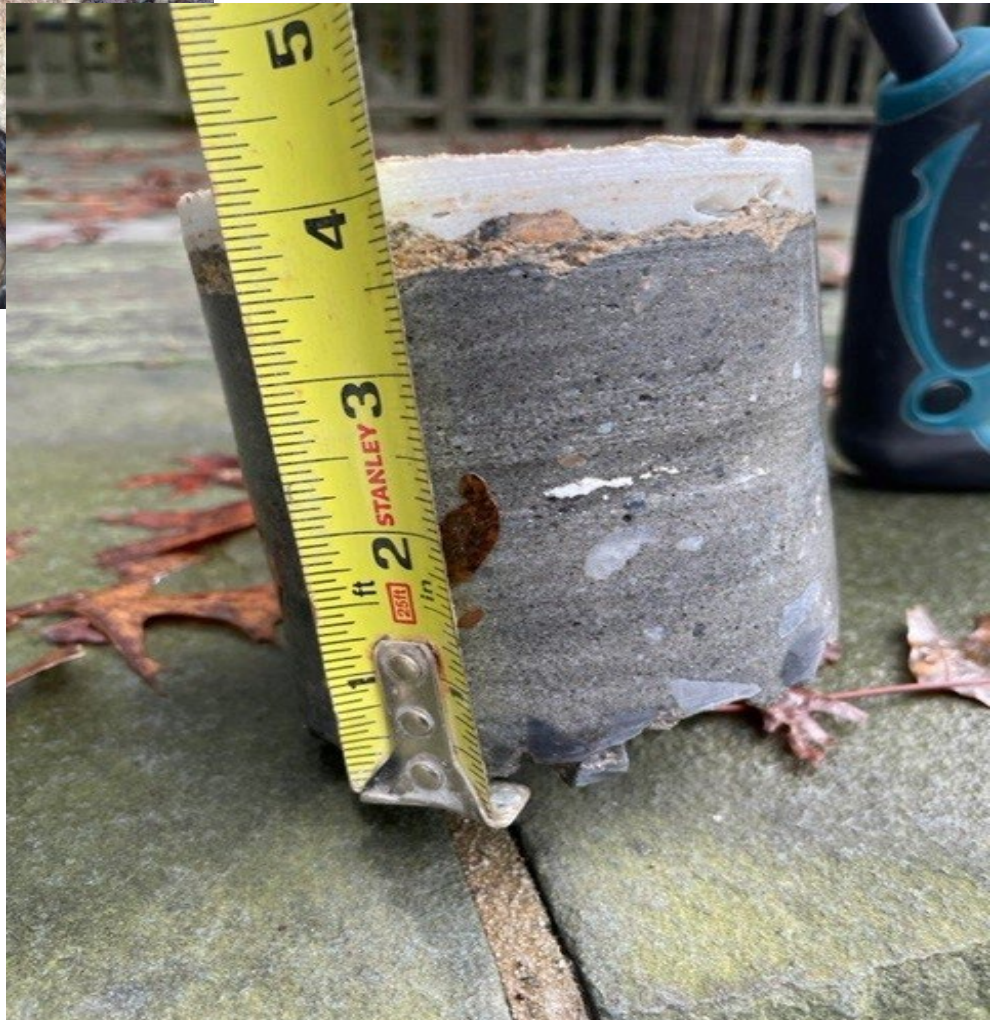
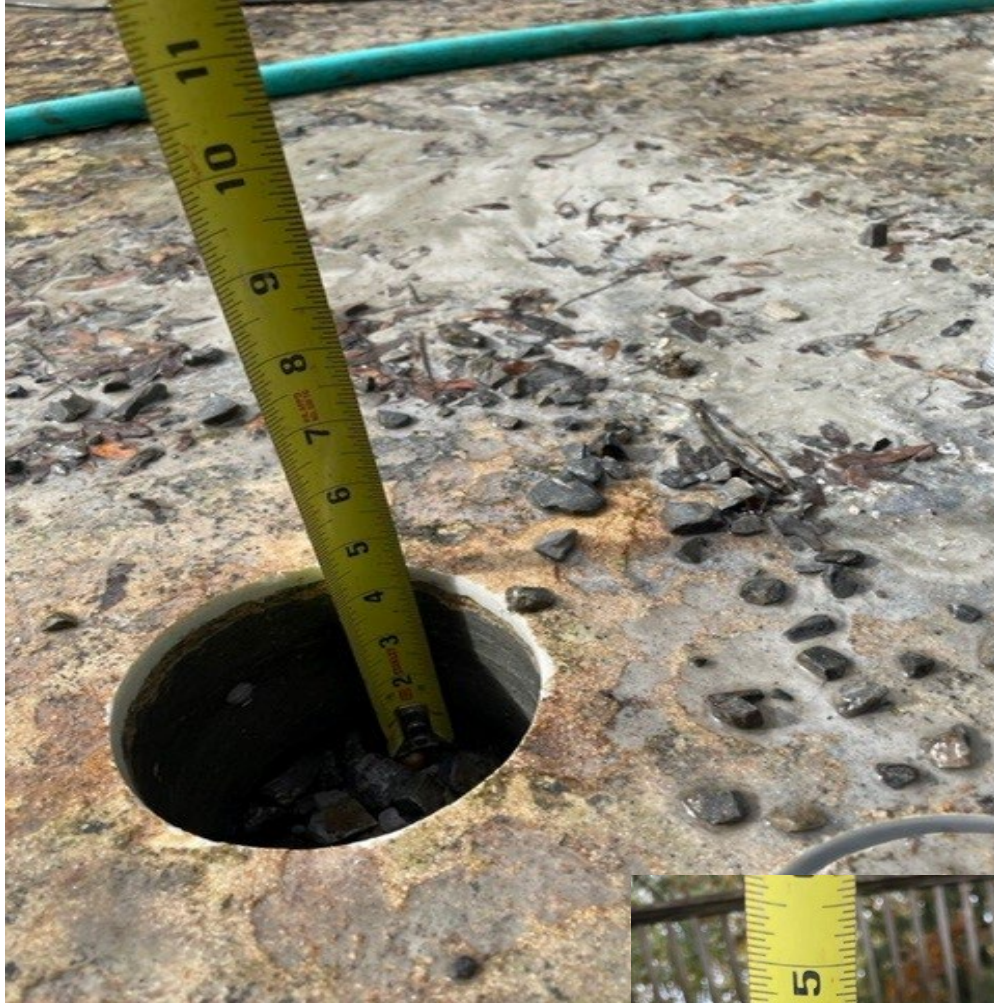
Core sample # 3: Shallow End Floor

Thickness of core is 3.5" overall with approximately 3" of clean gunite and .5" contaminated layer with sand mix. 3/8" of plaster was found on this core.

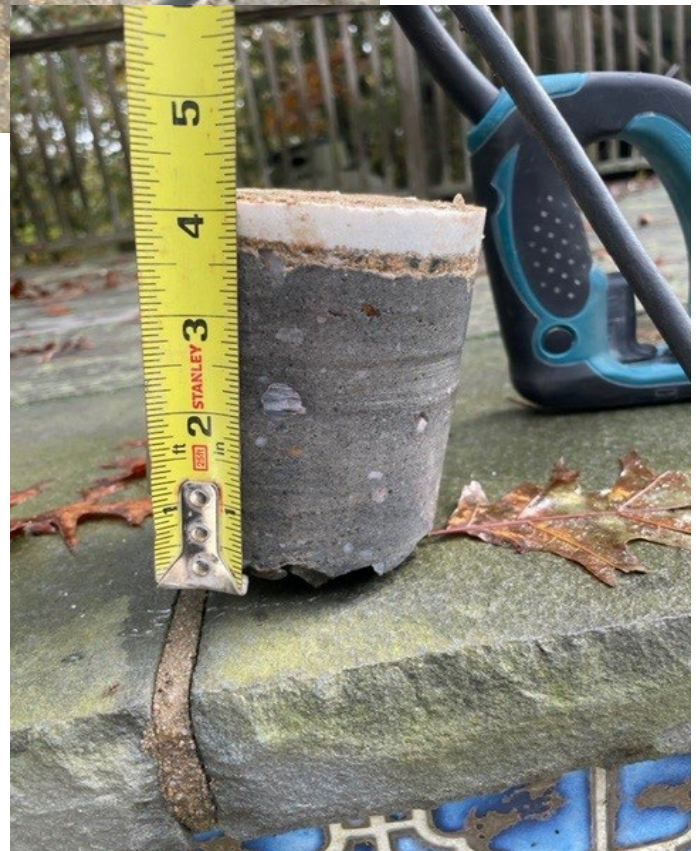
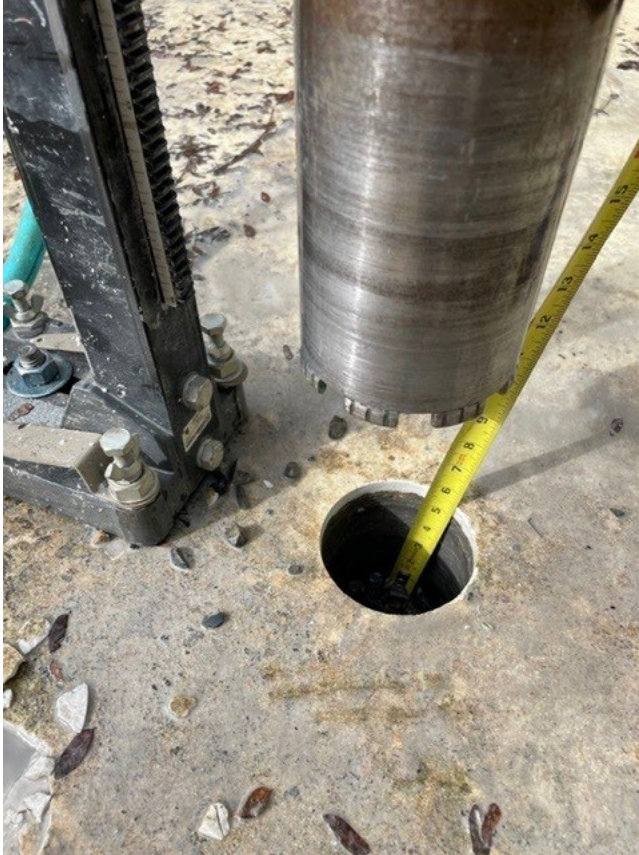
Core sample # 4: Pool Slope upper section

Thickness of core is 3.5" overall with approximately 3" of clean gunite and .5" contaminated layer with sand mix. 3/8" of plaster was found on this core.

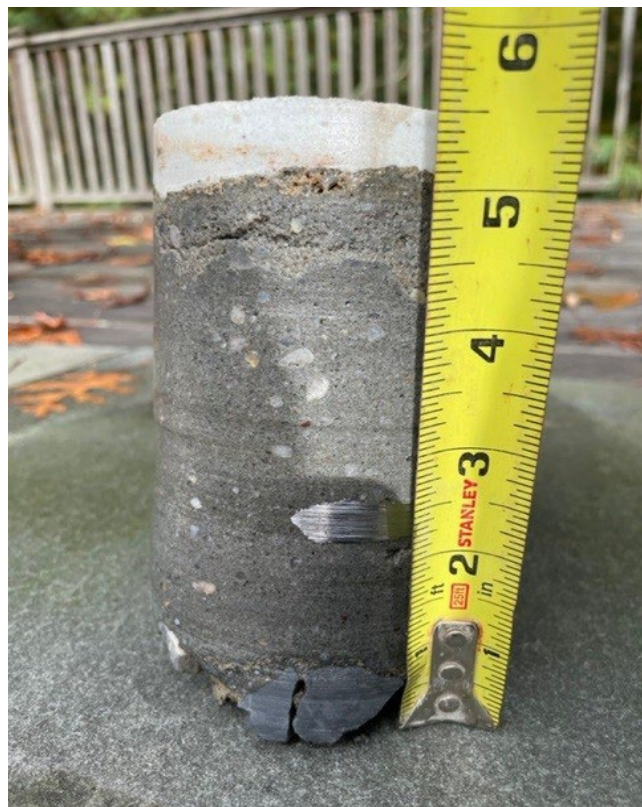
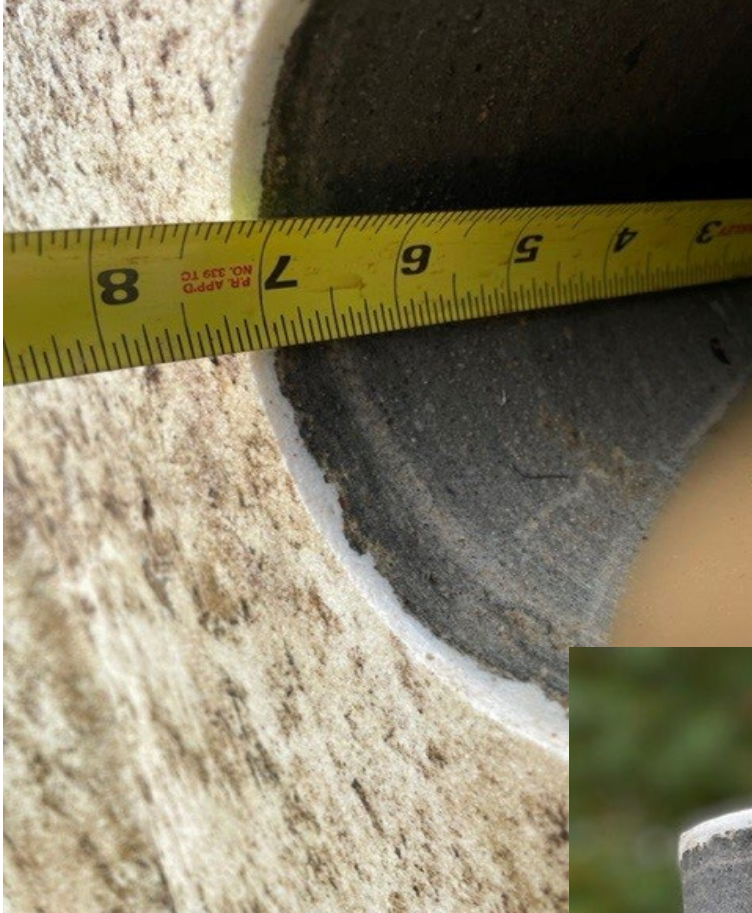
Core Sample #5: Deep End Floor

Thickness of core is 5" overall with approximately 4" of clean gunite and 1" contaminated layer with sand mix. 1/2" of plaster was found on this core.

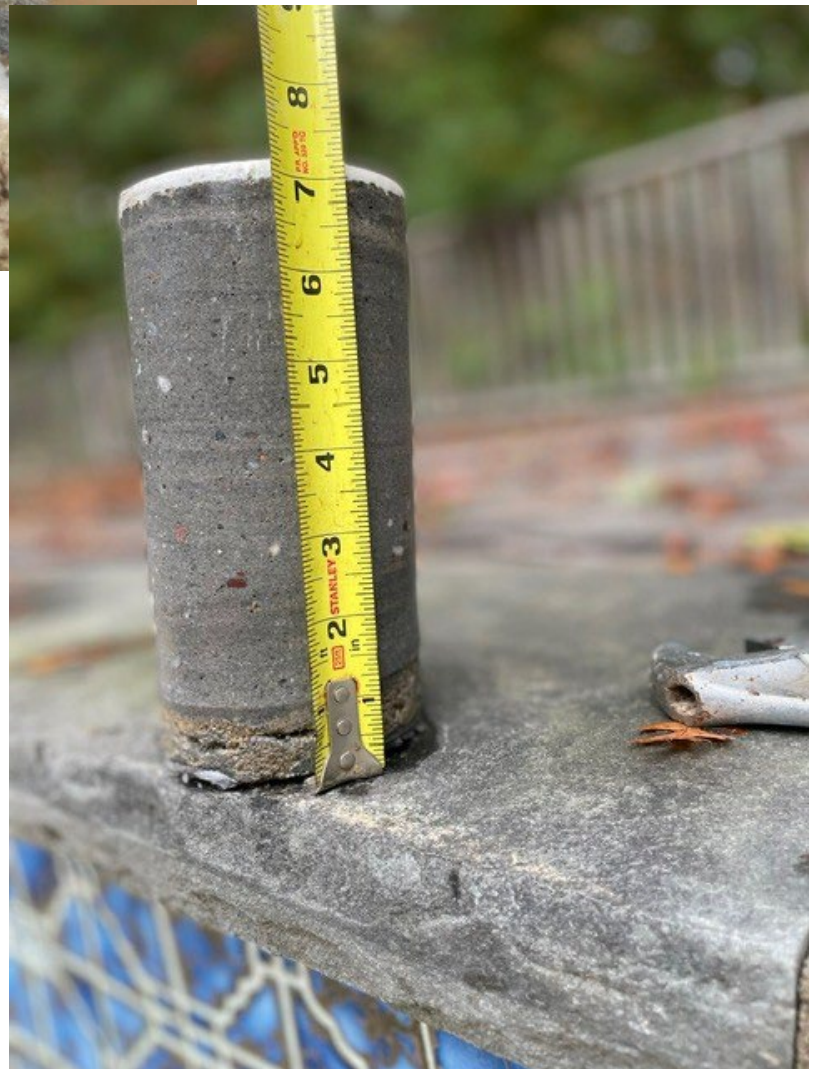
Core sample # 6: Pool Wall

Thickness of core is 6.75" overall with approximately 5.75" of clean gunite and 1" contaminated layer with sand mix. 1/4" of plaster was found on this core.

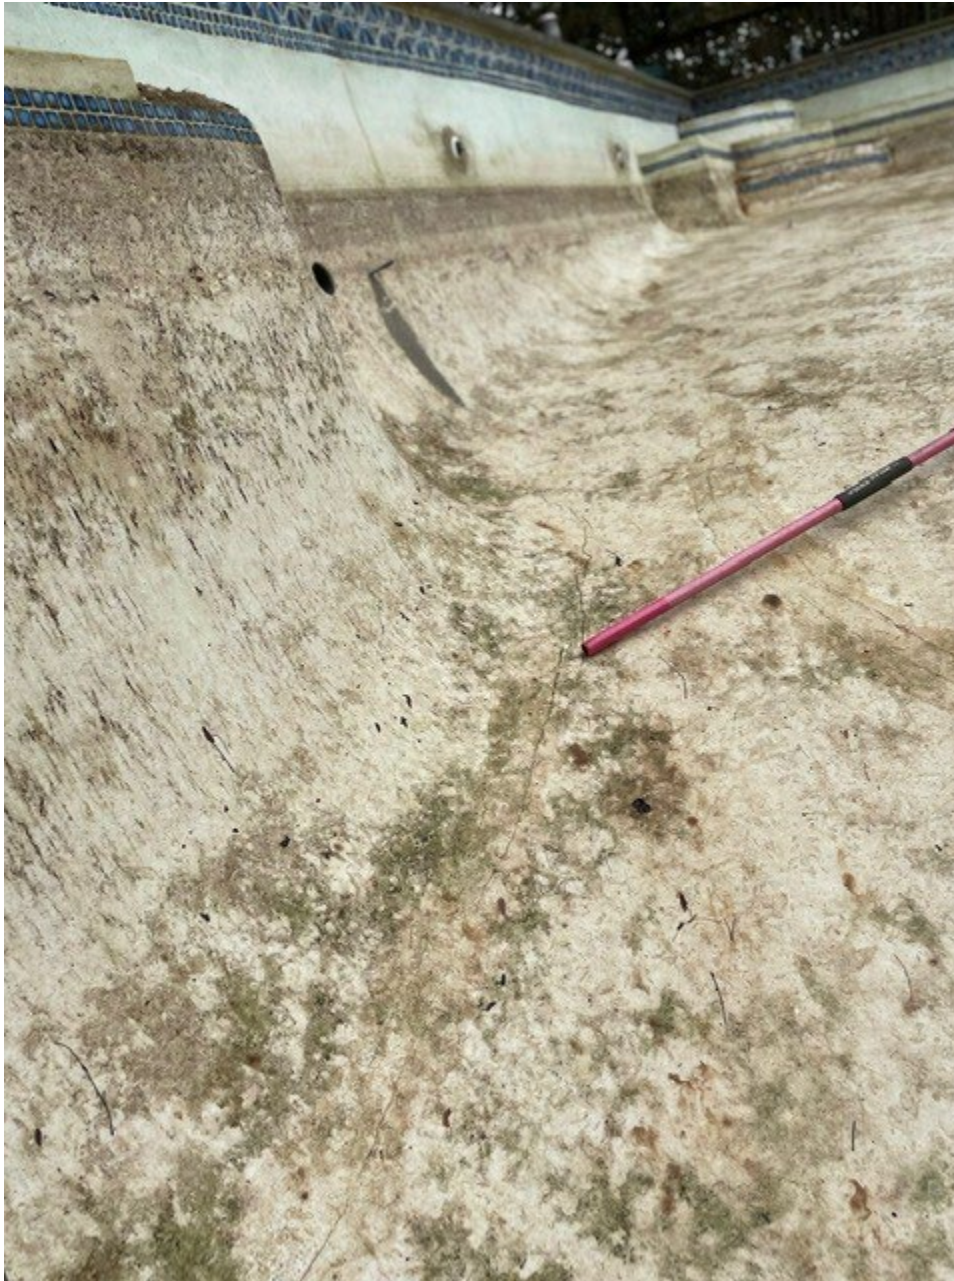
Additional Pool Photos: Structural Crack

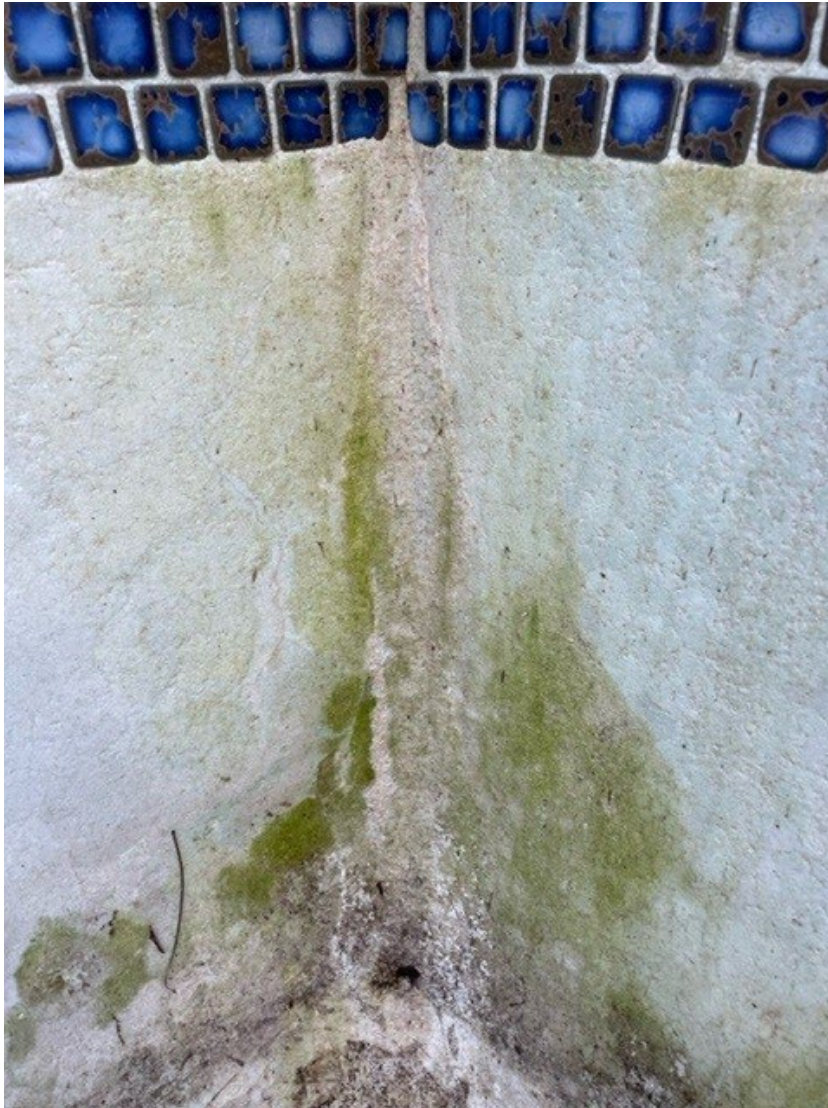
Additional Pool Photos: Shallow end previous repair
